## Expanding Lab Capabilities at MGV

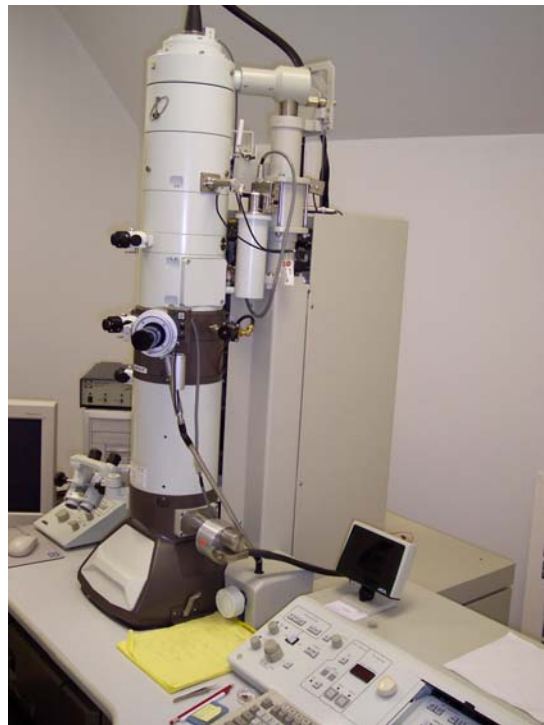
With the TEM many polymer processing issues can be evaluated on a molecular level.
